Case 368 : Narrative

Case Vehicle (A): 1999 Toyota	Vehicle (B): 2002 Ford
Type: Camry LE, 4-door sedan	Type: Taurus SES, 4-door sedan
Driver: 39-year-old female	Driver: 45-year-old male
CDC: 11-FLEW-2, 09-LBEW-3	CDC: 02-RFEW-3, 03-RZAW-3

CASE NO.: 368-03

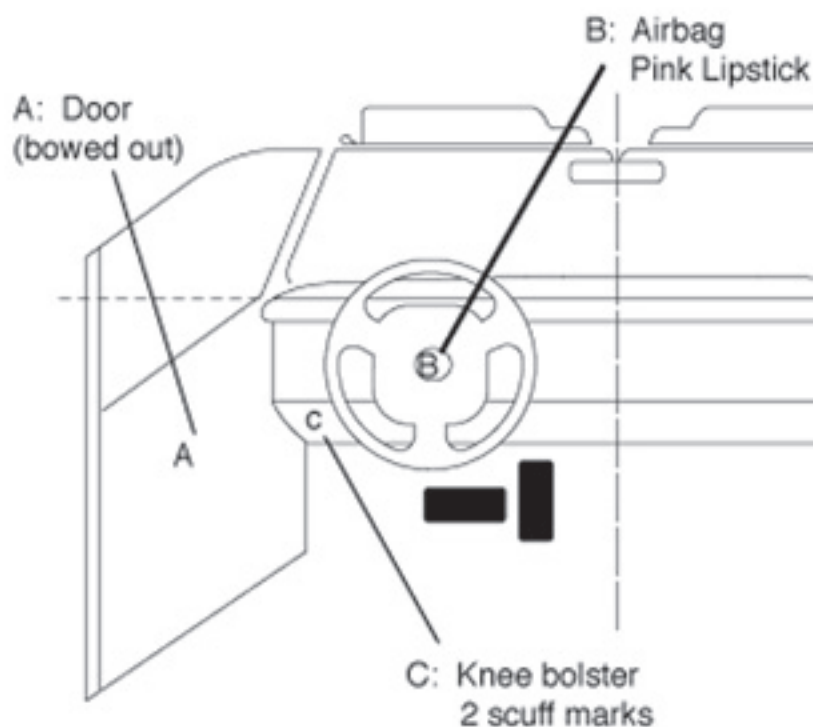
E:
center floor
console broken

belts:
driver - pretensioner fired and belt extended
left-rear - marks on sliding-latch plate
right-front - pretensioner fired and belt retracted
right-rear - no evidence

D: scuff, top of left
rear door panel
